**Wear Behavior in Thin
Layered Au/SS and Au/Mo
Coatings**

Final Report

**E. L. Courtright
J. W. Patten**

August 1982

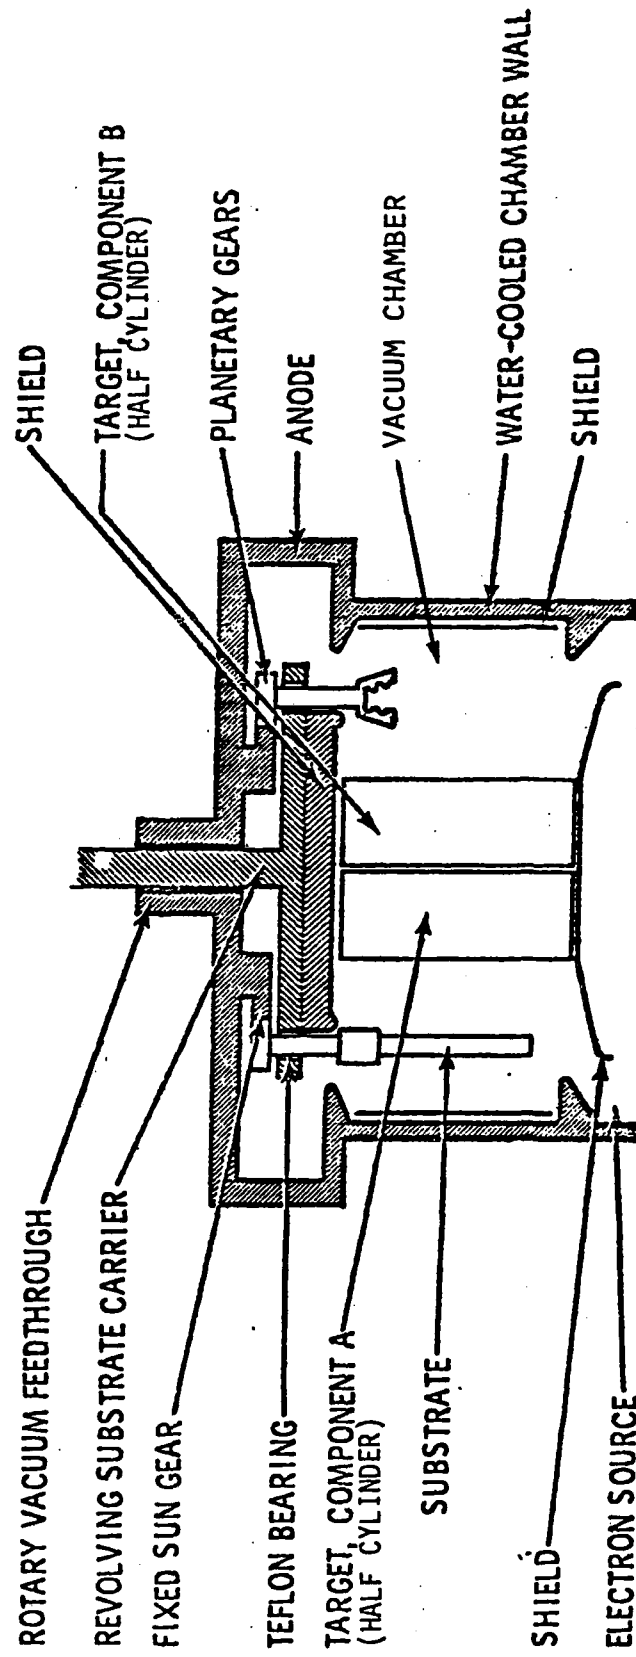
FIGURE 1. SCHEMATIC OF SPUTTER DEPOSITION SYSTEM USED TO DEPOSIT LAYERED COATINGS.

Deposition was performed in a sputtering apparatus schematically described in Figure 1. For further description of the basic phenomenon, the reader is referred to reference (14). Component A was Au and Component B was either Mo or Type 316 stainless steel. Difficulties in obtaining

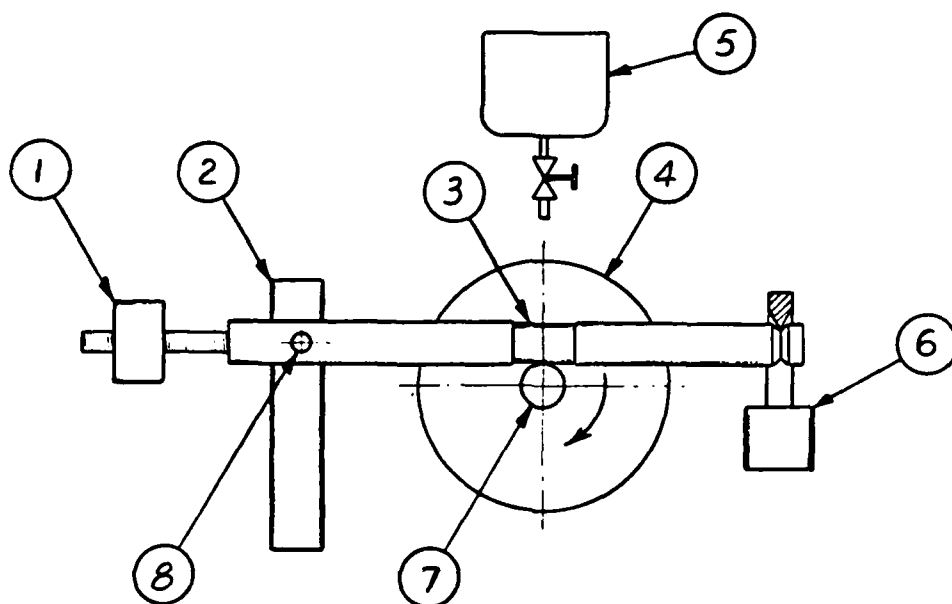
1. Counterweight
2. Pivot post
3. AISI 52100 slider. Rockwell C-62
machined to 16rms after hardening
4. Lathe chuck
5. Oiler
6. Loading weight
7. Wear specimen
8. Pivot

FIGURE 2. APPARATUS FOR PRODUCING AND COLLECTING WEAR DEBRIS.

The apparatus shown schematically in Figure 2 was assembled and used for wear testing. All tests were conducted in dry air. The oil flowing over the slide and wear specimen carried wear debris away from the slider-specimen contact area. The oil and entrained debris were collected in a clean glass dish below the wear specimen.

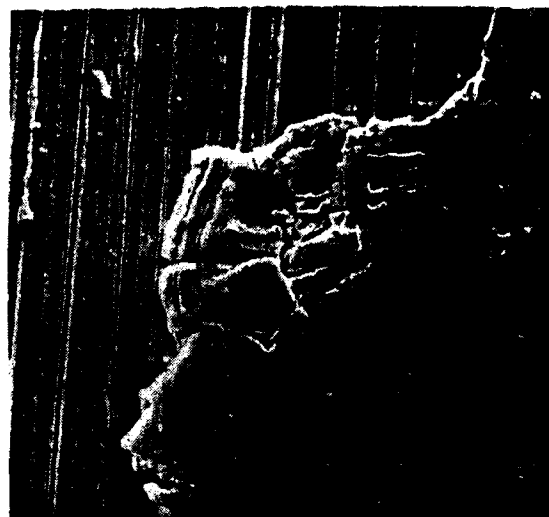
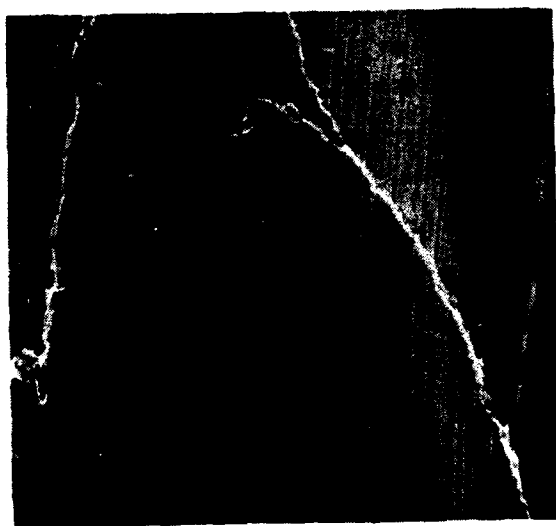
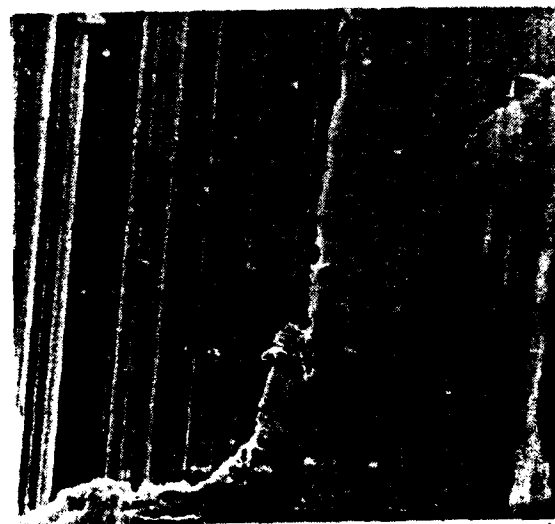
FIGURE 3. SEM MICROGRAPHS OF WEAR TRACKS
ON CAST Au WEAR SPECIMEN ONR-0.

Figure 3 shows an SEM characterization of wear tracks on specimen ONR-0 (cast Au). Note the smeared gold developing into overlayers. Figure 4 shows two wear particles on filter paper (background), obtained from this specimen. These particles seem to have developed from separation of an overlayer similar to the one shown in Figure 3, and include many layers of gold. Transmission Electron Microscope (TEM) examination of wear particles did not reveal any void formation. However, only 200 Kev was available and the particles were so thick that a definitive examination could not be conducted.

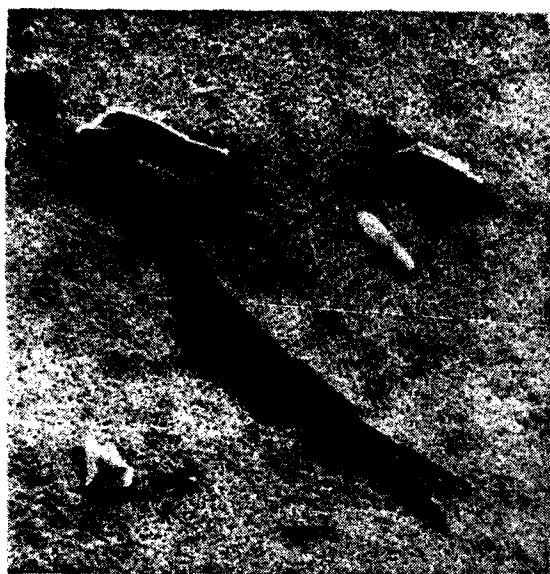
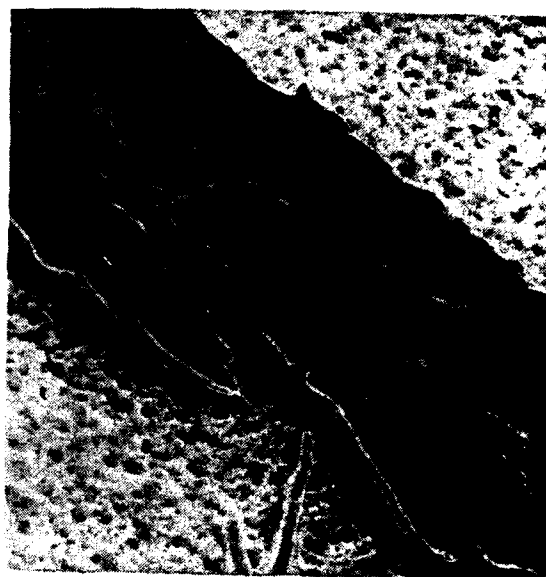
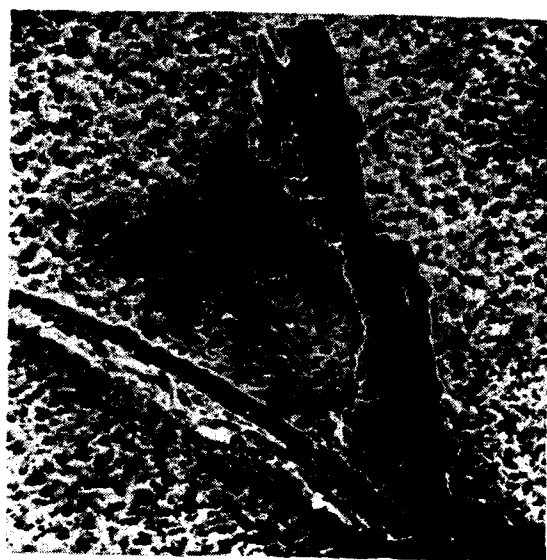
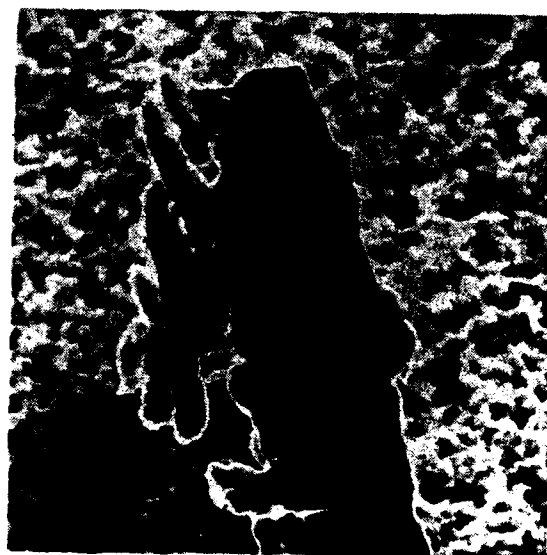
FIGURE 4. WEAR PARTICLE (ARROWS) OBTAINED
FROM CAST Au WEAR SPECIMEN ONR-0

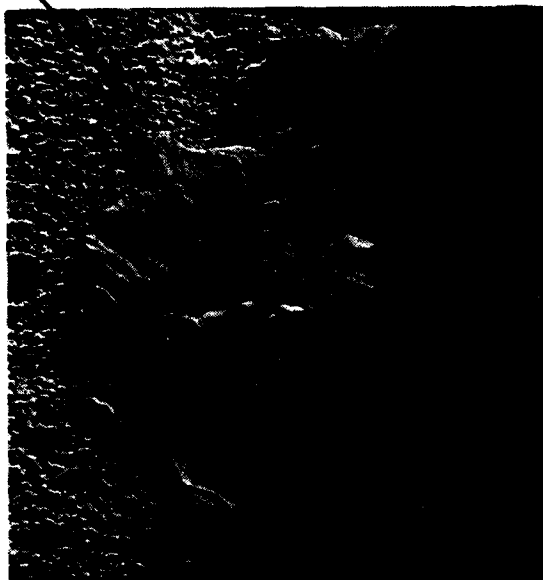
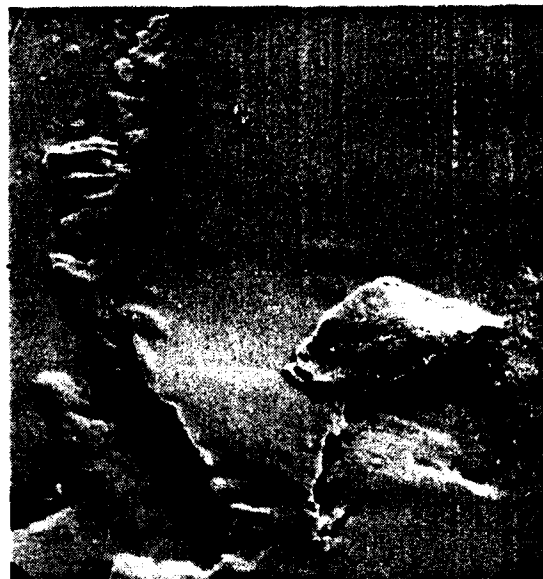
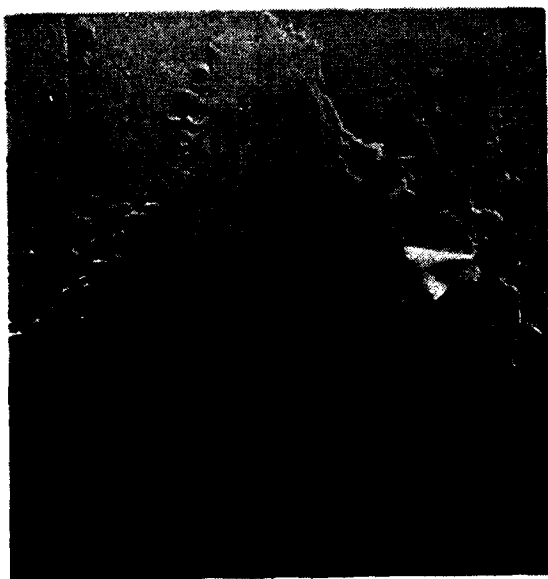
FIGURE 6. SEM PHOTOS OF A WEAR TRACK ON SPECIMEN ONR-2 (THICK SPUTTERED GOLD SURFACE). (A) LEFT ARROW INDICATES AS-SPUTTERED SURFACE. RIGHT ARROW INDICATES SLIDING DIRECTION.

The SEM photos in Figure 6 show a wear track from specimen ONR-2. This specimen was coated with 250 alternate stainless steel and gold layers,

approximately 830 Å thick. However, the last layer deposited was gold and was 1.3×10^{-3} cm (5×10^{-4} in) thick. The result was a pure sputtered gold surface, thick enough to exceed the range of dislocation image forces, supported by an underlying structure with the elastic properties and dislocation barriers of a layered material. From these photos, it is apparent that the wear track is similar to the wear track on cast gold (Figure 3). Pending separation of debris particles is particularly evident. The multi-layered character of these particles suggests that delamination has occurred and the separated particle rebonded to the surface. Since only gold was detectable by energy dispersive spectroscopy in the areas under these large separating particles, it is hypothesized that individual wear particles were built up either by gross plastic deformation (smearing) of successive layers of gold during sliding contact or by cold welding these particles together in the wear track. A large wear particle, generally consisted of many layers. Each layer was probably produced by one sliding contact event or one smaller debris particle and then displaced over and welded to previously produced layers. Large platelet debris particles could be reduced in thickness by subsequent sliding contacts in a manner similar to the techniques used to produce thin foils by pack rolling. This would allow formation of multilayered debris particles as thick or thicker than the outer layer without delamination of this layer or fracture across the as-deposited interface.

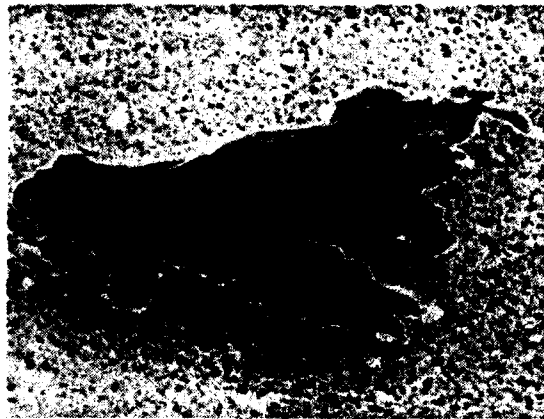
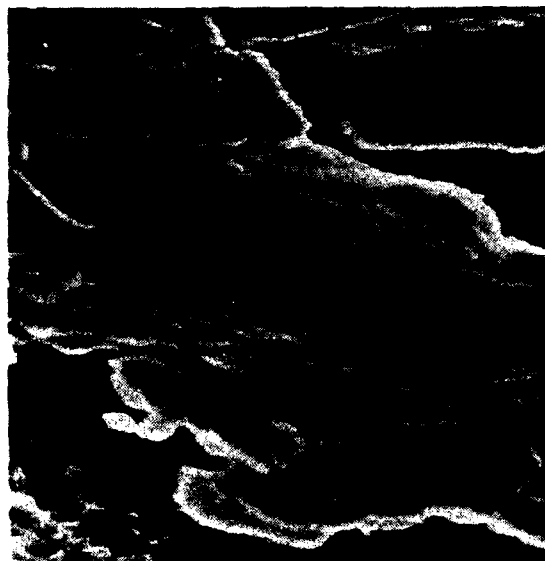
FIGURE 7. SEM PHOTO OF A SPUTTERED Au WEAR PARTICLE FROM SPECIMEN ONR-2.

Figure 7 shows typical gold debris particles, produced from specimen ONR-2. These particles clearly could have been produced by the above model. Some of the particles were estimated to be at least 1×10^{-3} cm (4×10^{-4} in) thick and were comprised entirely of gold. No iron was detectable in the wear track indicating that delamination was restricted to the gold layer and that the underlying stainless steel acted as an effective barrier to dislocation propagation. Fracture occurred, close but not adjacent to the Au-SS interface.

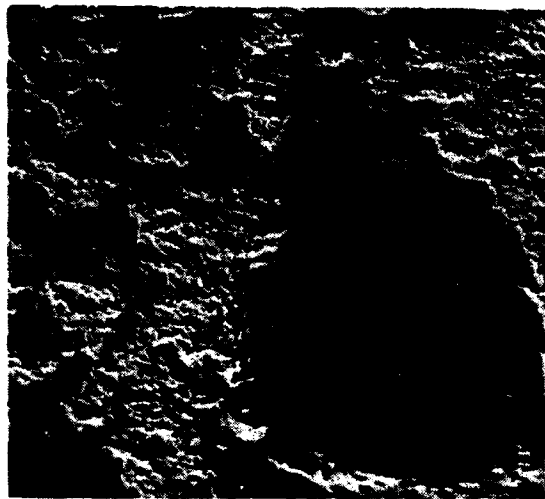
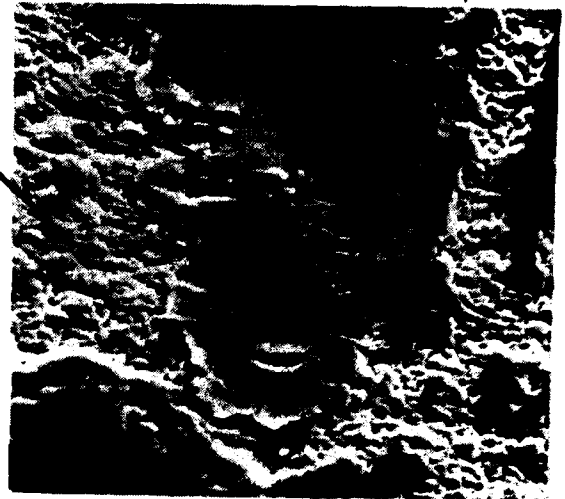
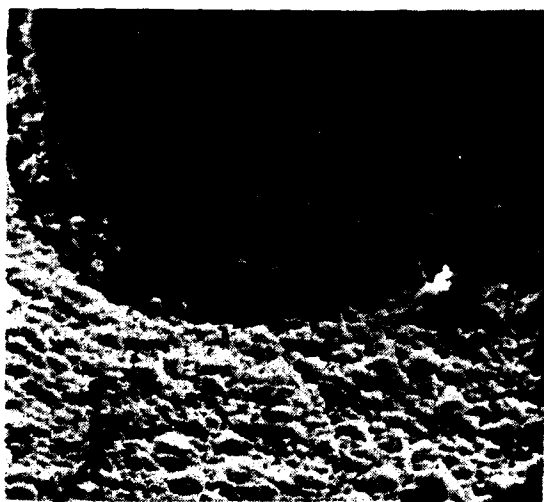
FIGURE 8. SEM PHOTOS OF A WEAR TRACK FROM SPECIMEN ONR-1.
THE ARROWS POINT TO THE STAINLESS STEEL UNDERLAYER.

Figure 8 shows a wear track from specimen ONR-1. The outer gold layer of this deposit was thinner than for specimen ONR-2. The deformed areas of this wear track were similar to the track in pure gold, but the sheet thickness appeared to be less. Extensive ductility was still present in the layered deposit, as expected. Both the gold and the stainless steel layers were approximately 1600-1700 Å (1.6×10^{-5} cm) thick in the sample. This thickness should be greater than the range of dislocation image forces but is obviously less than the thickness of wear debris found in the sputtered outer layer of specimen ONR-2.

The wear track shown in Figure 8 shows the condition of the surface after 100 meters of sliding distance. Large areas of the stainless steel underlayer appear exposed. It was not possible to determine whether the increased wear rates and production of larger delamination particles began after the 1600 Å gold outer layer was completely removed and the stainless steel underlayer became the wear bearing surface, or if several layers were removed before the process accelerated. It is clear, however, that the delamination process changes once the soft gold outer layer has been penetrated.

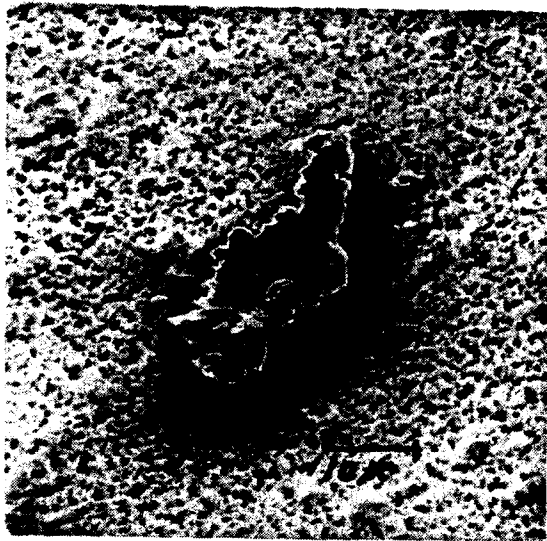
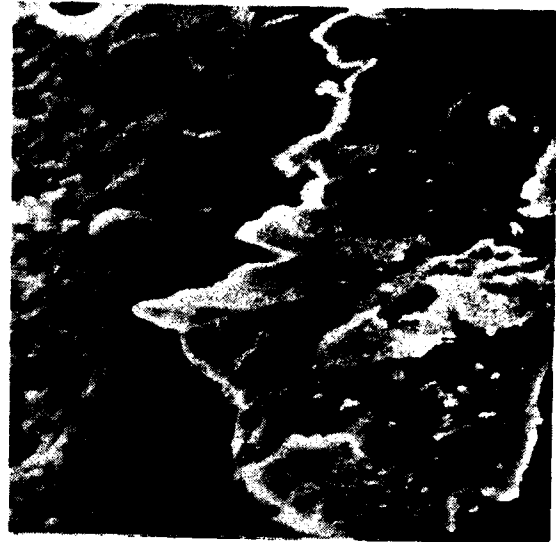
FIGURE 9. SEM PHOTOS OF WEAR DEBRIS PARTICLES FROM SPECIMEN ONR-1. SLIDING DISTANCE 25 METERS.

Figure 9 shows some of the wear debris particles from specimen ONR-1. Thickness of individual layers within large particles was approximately 500 to 1000 Å, clearly less than the sputtered layer thickness and less than the layer thickness within pure gold debris particles. However, the detailed structure was on a smaller scale than for pure gold and seemed to show less ductility. In addition, smaller debris particles were observed. Some of the details could not be easily resolved with the SEM. No evidence for such (individual) fine particles was found in the debris obtained from pure cast (ONR-0) or sputtered gold (ONR-2).

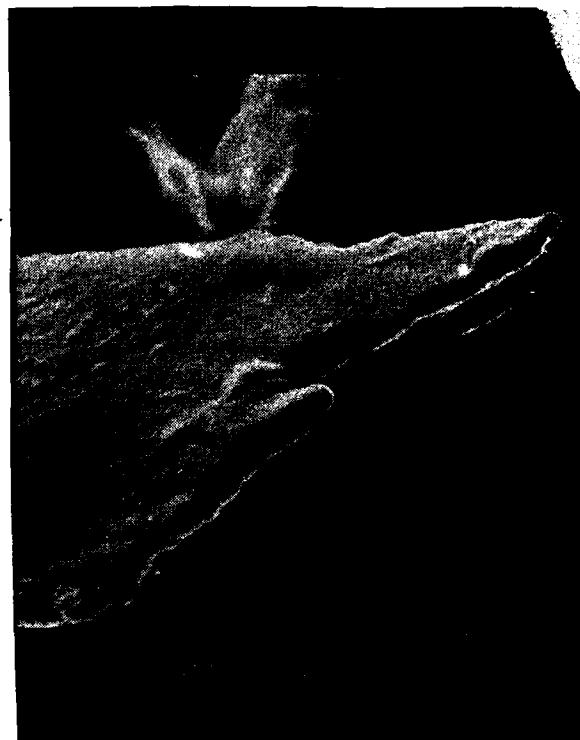
FIGURE 10. DEBRIS PARTICLE FROM SPECIMEN ONR-1
SLIDING DISTANCE 600 METERS.

As wear continued on specimen ONR-1, the wear rates began to increase dramatically and the debris particles increased in both size and thickness. Figure 10 shows a debris particle on wear track ONR-1 3B at a sliding distance of 600 meters. This particle is approximately 7000 Å in thickness which is on the order of four to five layers of gold and stainless steel. Energy dispersive spectroscopy confirmed that both gold and stainless steel were present in this and other similar particles from this particular wear track. The surface of this particle is relatively clean and does not contain evidence of multiple compacted layers as previously observed in the all gold debris from ONR-2, see Figure 7. It was not possible to determine if the surface layer was Au or SS because penetration of the electron beam easily exceeds the layer thickness.

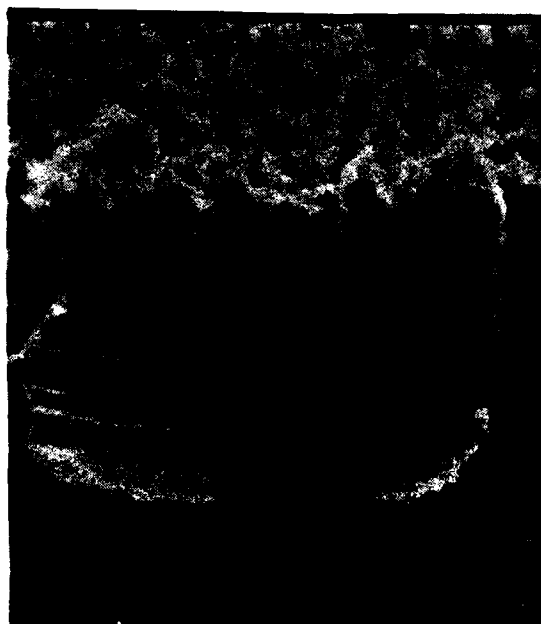
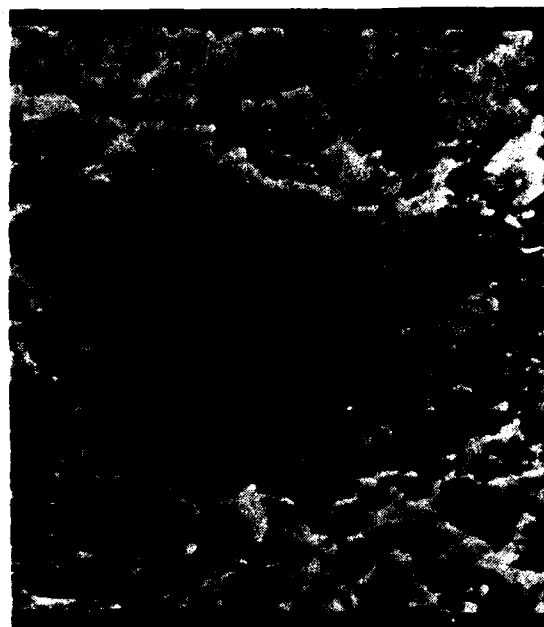
FIGURE 12. DEBRIS PARTICLES FROM WEAR TRACK OF SPECIMEN ONR-4. THE PARTICLE AT LEFT IS FOR A 550 GRAM LOAD, 83 MM/SEC SURFACE SPEED, AND 50 METER SLIDING DISTANCE. THE PARTICLE AT RIGHT IS AFTER 100 METER SLIDING DISTANCE.

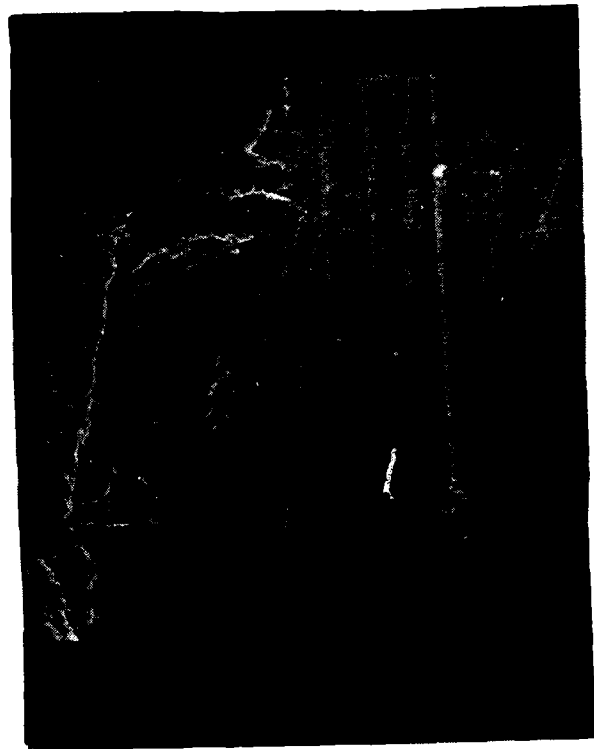
FIGURE 13. WEAR TRACK FOR Au/Mo SPECIMEN ONR-4. SAMPLE
LOAD 1100 GRAMS, SURFACE SPEED 250 MM/SEC (LEFT),
83 MM/SEC (RIGHT), SLIDING DISTANCE 100 METERS.

Figure 13 shows a wear track for ONR-4 after the load had been doubled and the surface speed increased by a factor of three. Catastrophic failure of the coating in the wear track region is observed. Evidence of columnar structure in the fragments shown along the edge of the wear track indicate that the layers did not separate by delamination, but rather by breaking off large chunks of deposit, thereby demonstrating that the inter-layer bonding was very strong. It is clear that the wear process in the Au/Mo coatings did not proceed by general layer by layer attrition. Failure apparently occurred at the coating/substrate interface as the loading conditions increased in severity.

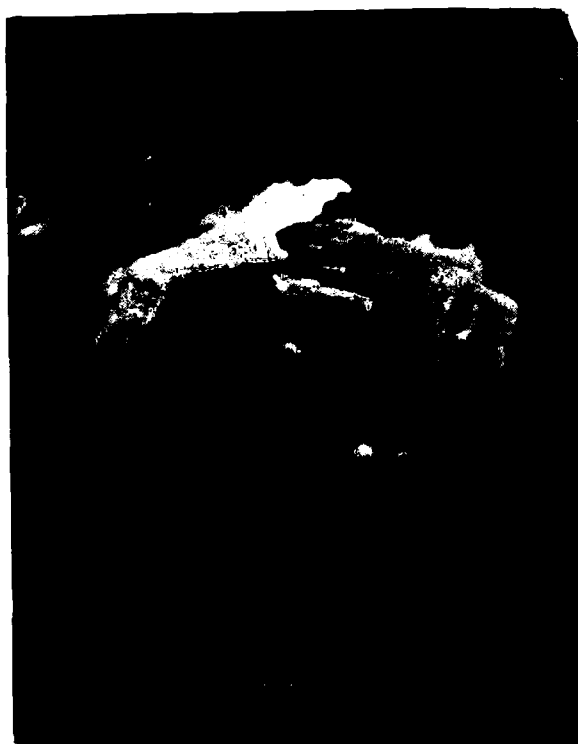
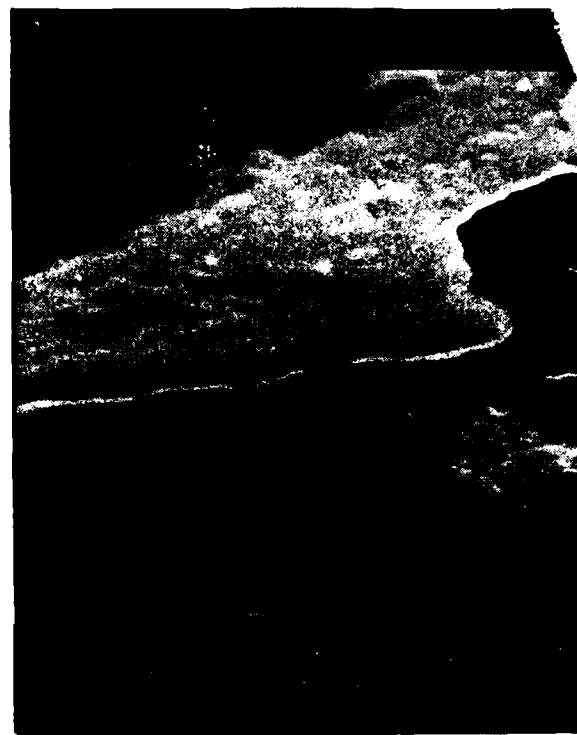
FIGURE 14. WEAR DEBRIS FROM Au/SS SPECIMEN ONR-6. SAMPLE
LOAD 550 GRAMS, SURFACE SPEED 83 MM/SEC,
SLIDING DISTANCE 300 METERS.

Wear rates remained consistently low over an extended period of time and although the particle debris generated did not produce a large volume of material, the individual wear particles as shown in Figures 14 and 15 were much larger in size and in thickness than expected. These particles ranged from 5000 to 8000 Å in thickness and thereby consisted of 50 to 80 as-sputtered layers. Energy dispersive spectroscopy confirmed the presence of both Au and SS. The surface of some particles, see Figure 15, were somewhat rougher than those observed from ONR-1 (compare Figure 10) and some of the step-like features most likely contain more than one as-sputtered layer.

Energy dispersive x-ray analysis could not be used to prove that the horizontal fracture layers were gold. However, if the subsurface shear zone produced by the slider was trapped in one or more soft gold underlayers, then dislocations propagating within these zones would be reflected at the stainless steel boundaries located above and below. Continual movement would lead to void formation and coalescence. As delamination starts within a zone, the stress concentration at the interface is apparently sufficient to force propagation across the interface leading to the type of edge ductility observed in Figures 14 and 15.

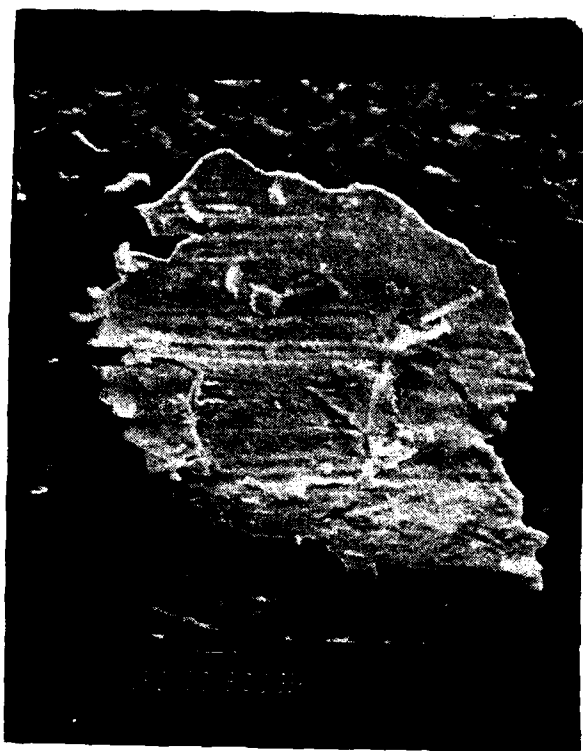
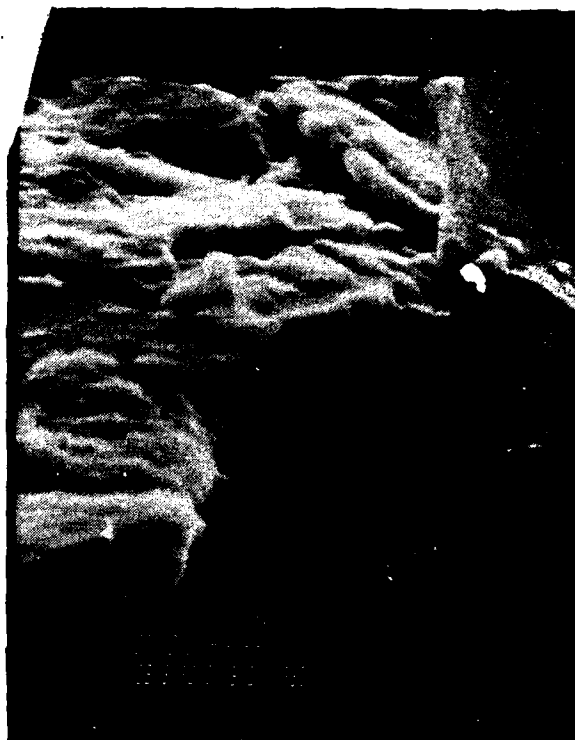
FIGURE 15. WEAR DEBRIS FROM SPECIMEN ONR-6. SAMPLE
LOAD 550 GRAMS, SURFACE SPEED 83 MM/SEC,
SLIDING DISTANCE 1200 METERS.

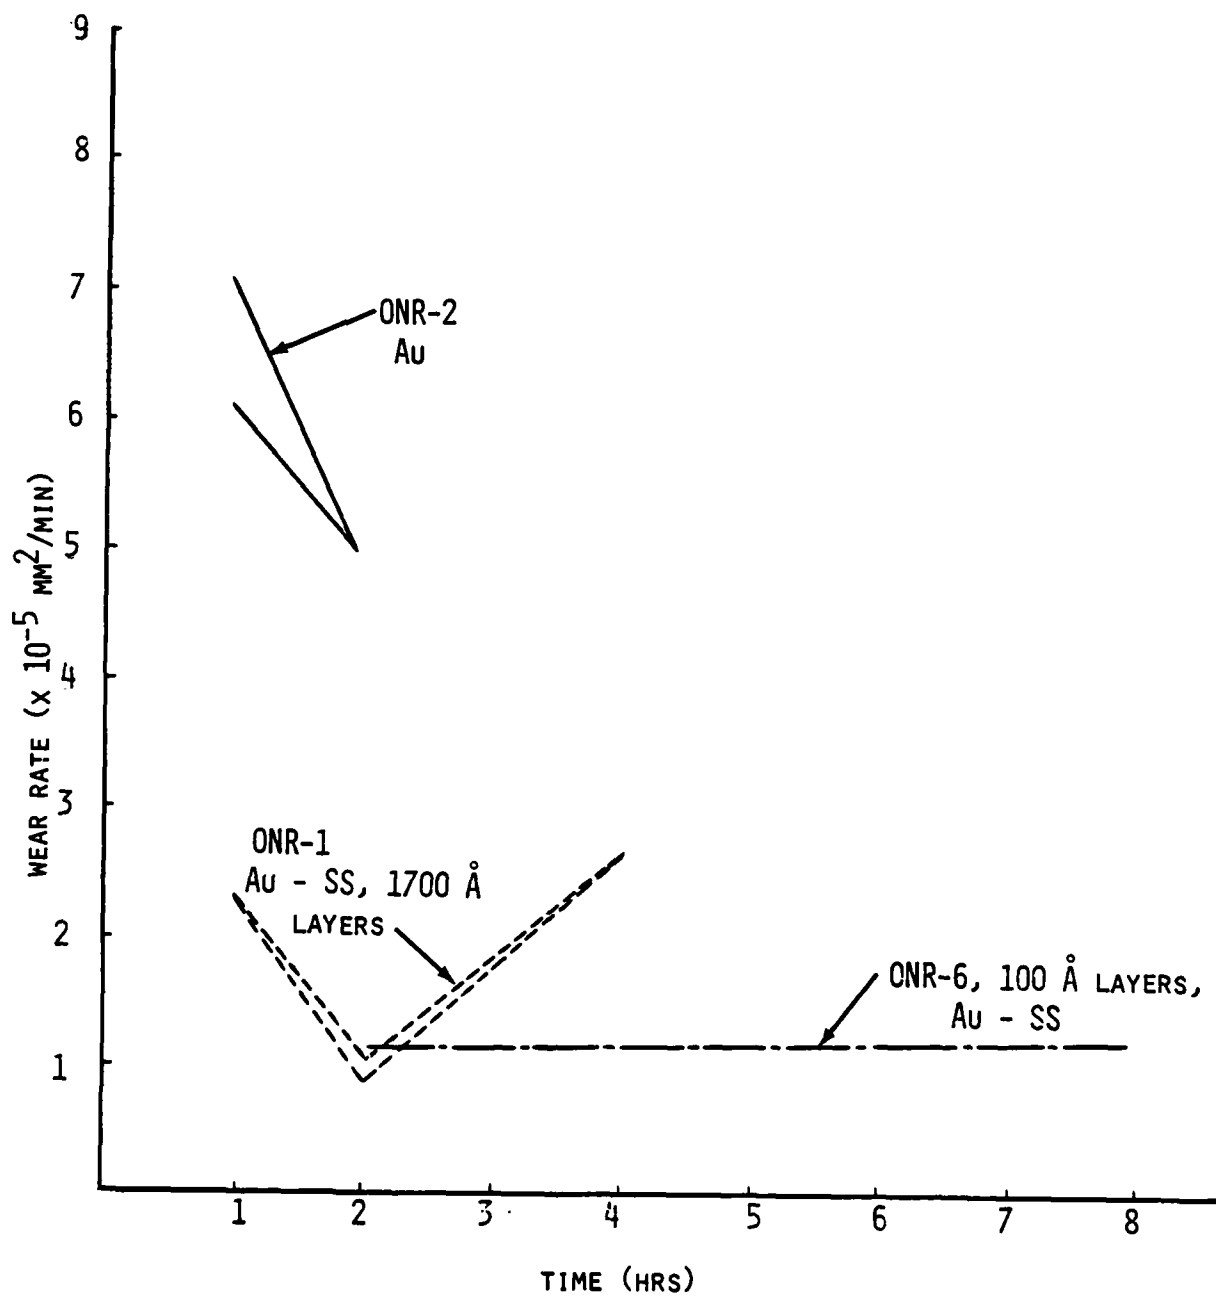
FIGURE 17. WEAR RATES AS A FUNCTION OF TEST DURATION.

Optical cross sections of wear tracks similar to those shown in Figure 16 were used to measure the volume of material removed and to calculate wear rates. This was done at periodic intervals. The result shown in Figure 17 include only comparisons made for test conducted with similar loads (550 grams), speed (83 mm/sec) and geometry.

There are too few data points in Figure 17 to be conclusive and the scatter reflects the measurement uncertainty; however, a consistent trend of decreasing wear rate as a function of gold thickness was recorded. A weak correlation between wear rate and the type of debris was observed. In general, the very large multilayered wear debris particles were found in conjunction with higher rates. Particle size and thickness decreased when
